Rehabilitation of Earthquake affected South Nawin Dam, Myanmar

Ms. Htoo Htoo Aung – Assistant Engineer (Civil)

Irrigation and Water Utilization Management Department (IWUMD)

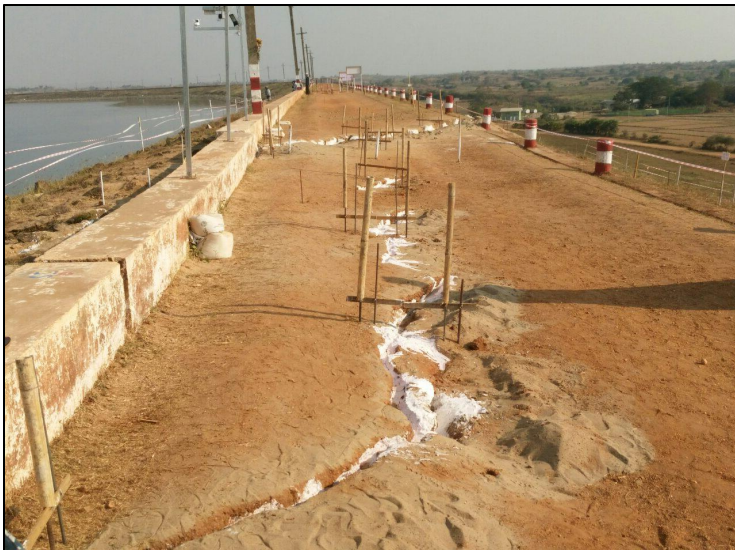
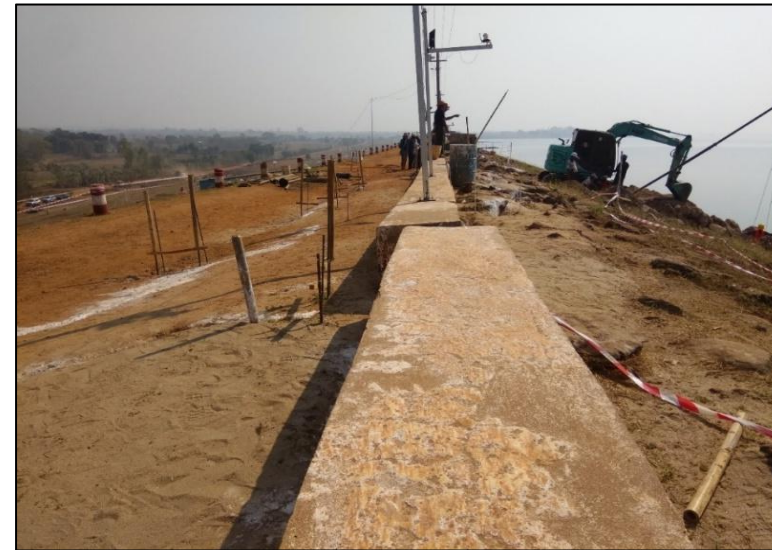
- On October, 2018 the earthquake occurred at South Nawin dam.
- It caused several streaks of cracks and subsequent settlement of the dam embankment.
- The cracks run in parallel with the dam alignment and triggered the persistent settlement in the section of cracks.

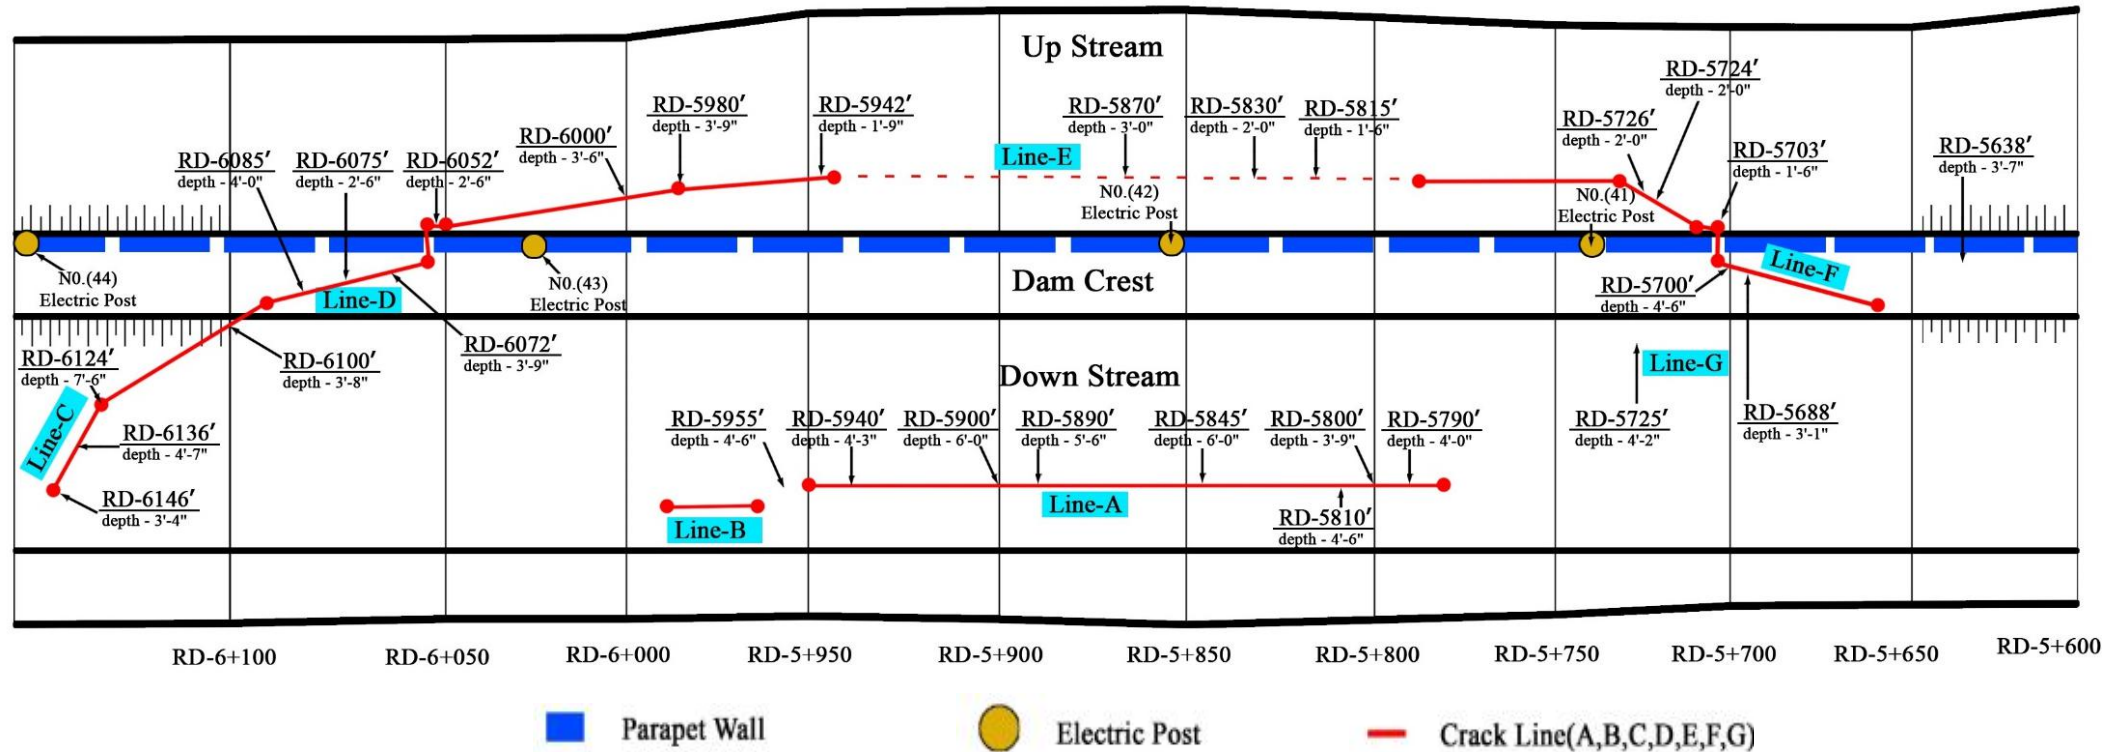
□ Crack map

- Between RD-5650 ft to 6150 ft
- Surface cracks were traced up to the middle of the embankment with two directions of vertical and oblique to the downstream of dam.

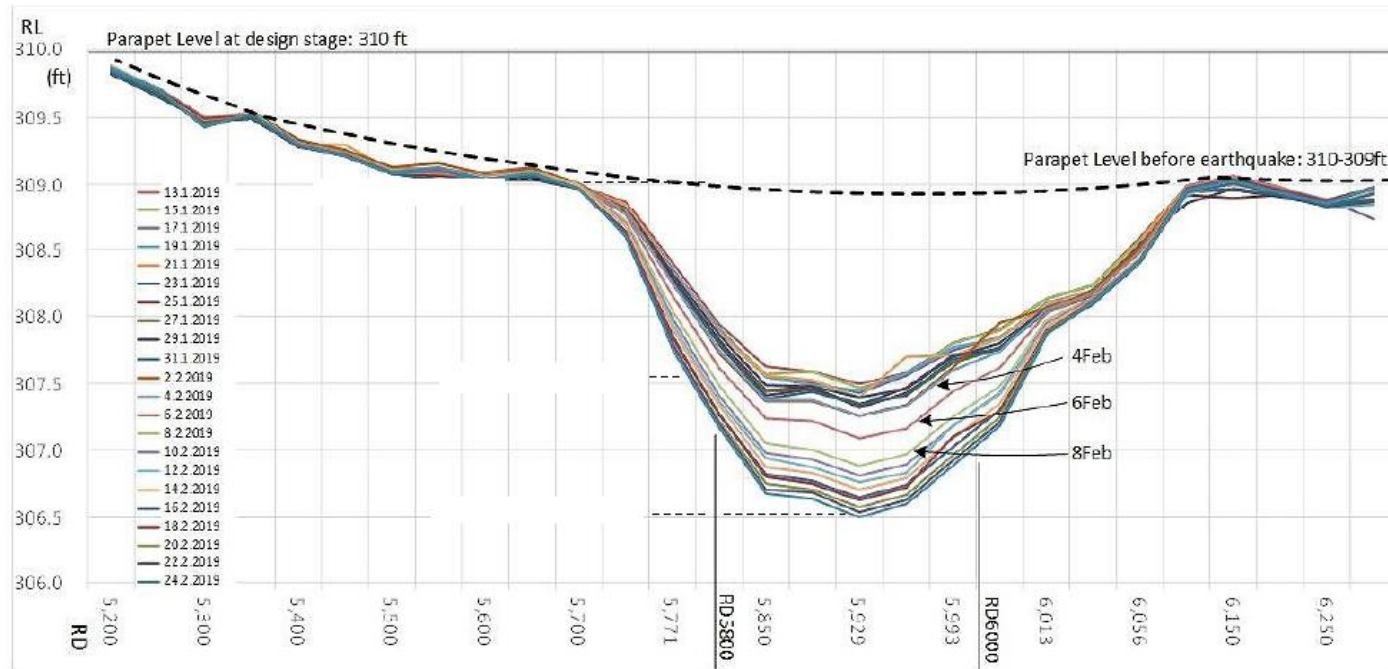
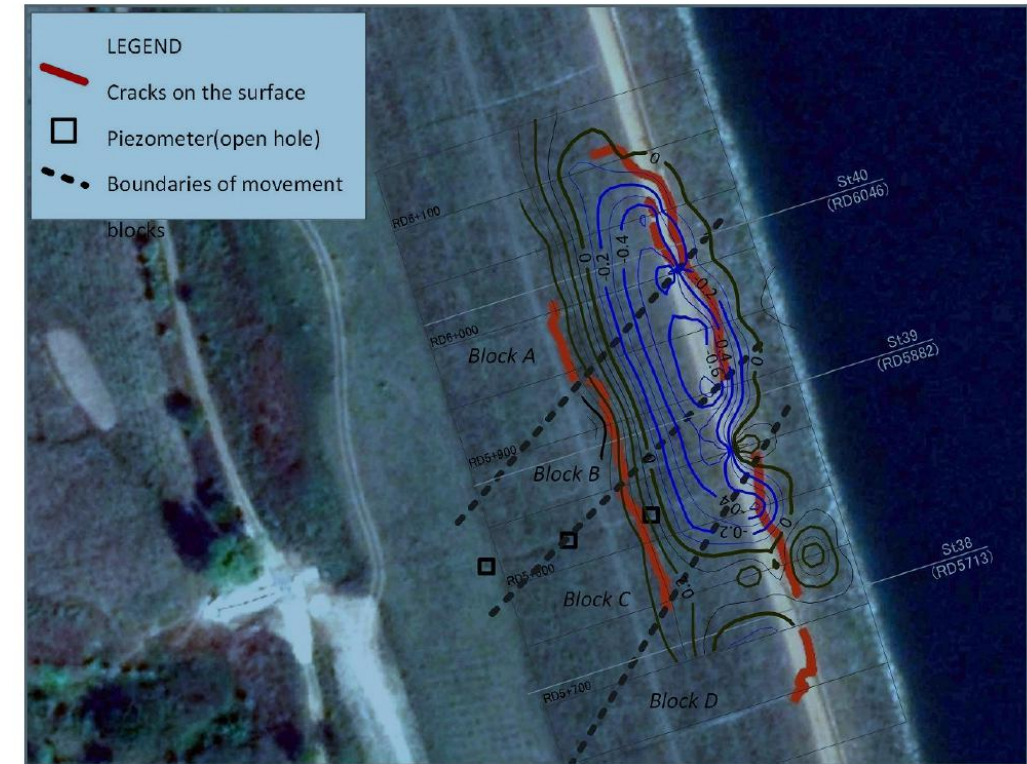
□ Settlement

- Total settlement : 2.5 ft in 4.5 months
- Average settlement rate : 0.16 ft/day in 4.5 months
- Maximum settlement rate : 1.02 ft/day (6.2.2019) along with a rapid change of water level in the reservoir
