Managerial Achievements on Overseas Dam in Safety and Reservoir under Normal Operation

Yunnan United Power Development Co.,Ltd : Myanmar Shweli(1) Hydropower Station

20 November, 2021

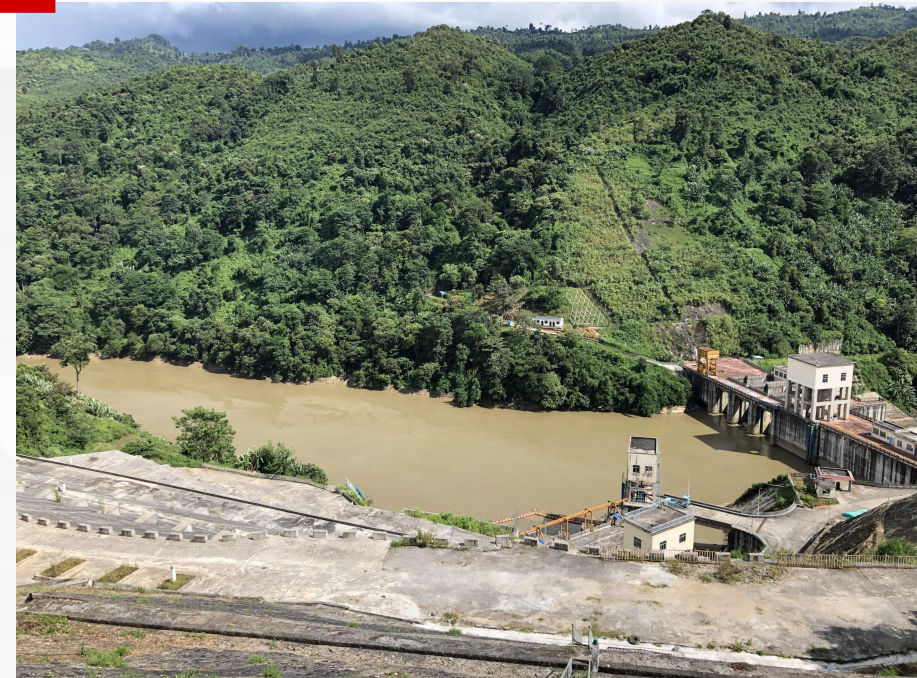
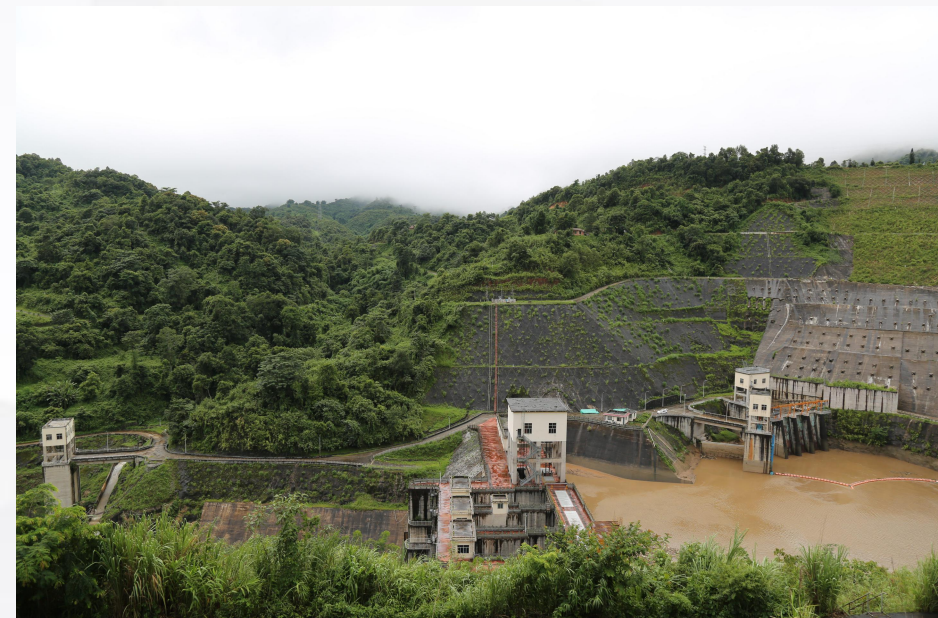
Brief Introduction

☑ The power station head complex is located near Mantat Village, around 30km away from the Sino-Myanmar border, and distributed in a stream segment of around 8km between upstream around 1km of Nam Myin Ditch exit and downstream of Andrew Ditch exit, on the right bank of Shweli River.

☑ In the head complex area, the water current is turbulent, with continuous rocky beach, and water surface elevation drops more than 300m in a stream segment of around 8km, with high hydraulic slope and in an unbalanced V-shape valley, generally steep on the left bank and gentle on the right bank.

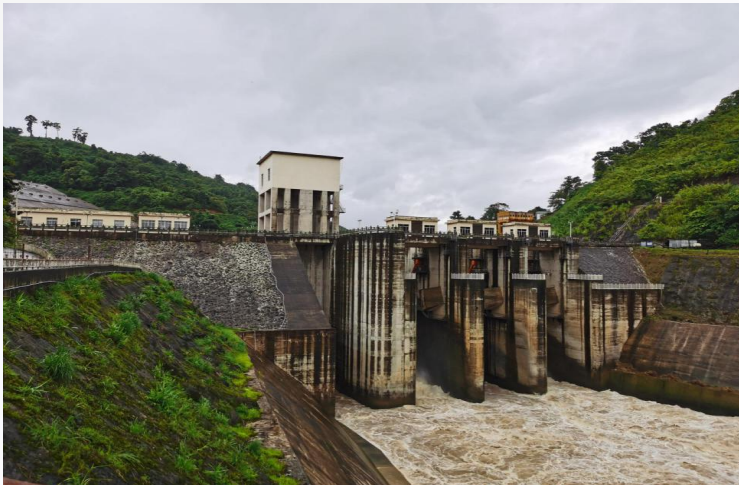
☑ Water diversion system

Distributed on the right bank, consisting of water-diversion tunnel, upstream surge shaft, and penstock (built-in).

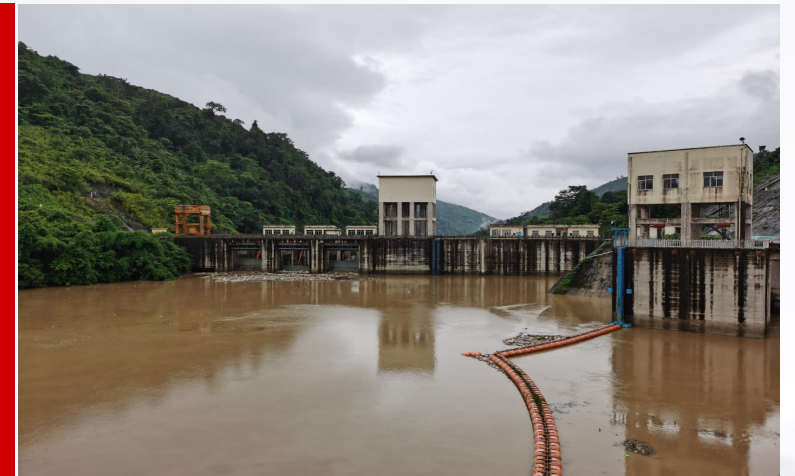
☑ Powerhouse complex

including ground main powerhouse, auxiliary powerhouse, and indoor GIS booster station

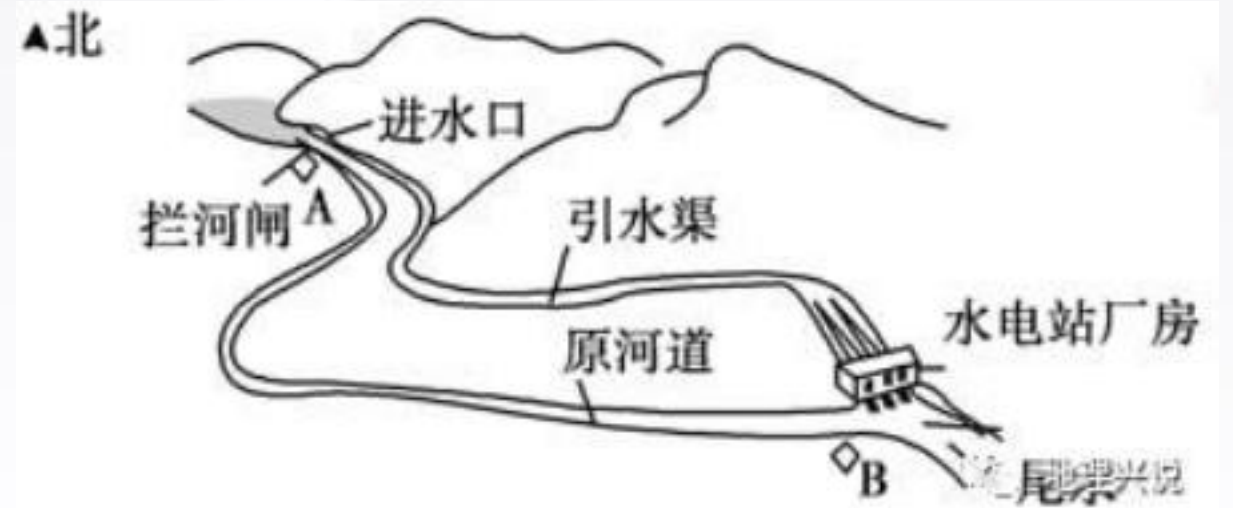
Diversion-type station :

Select the river segment with steep sloping and concentrated elevation drops, and utilize a gentle sloping water diversion tunnel to fulfill the required elevation drop (water drop).

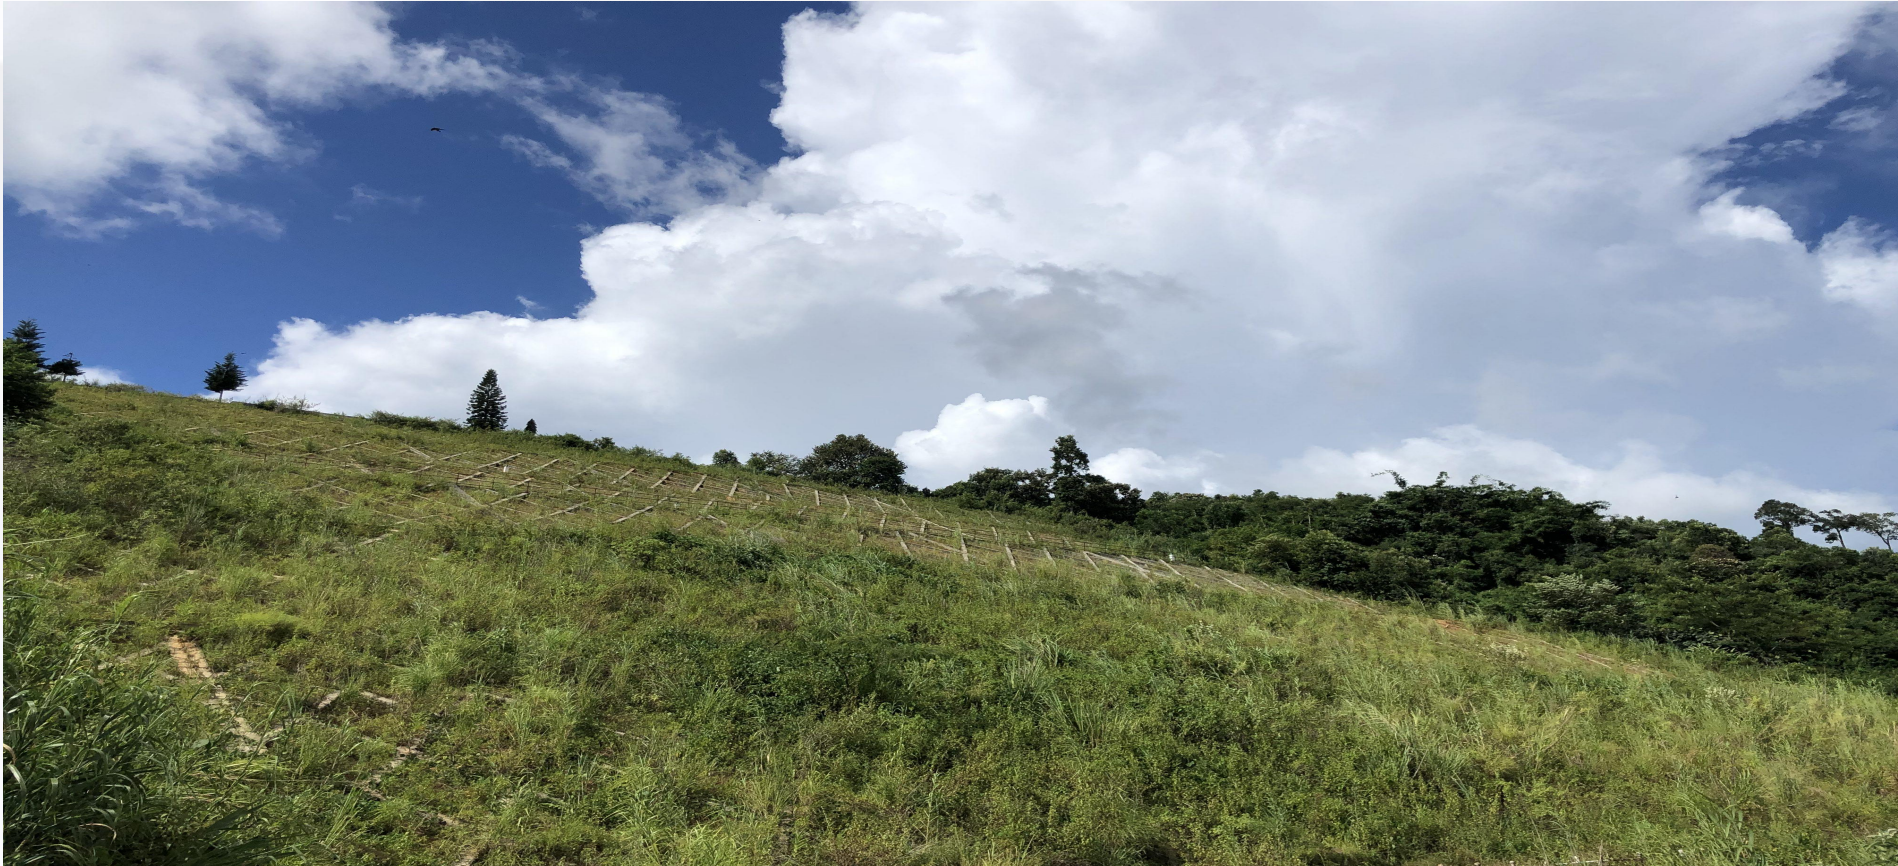
Within less than 2 years, the upper excavation area is through technical measures regained for vegetation cover, both project construction and environmental protection benefit are fulfilled.

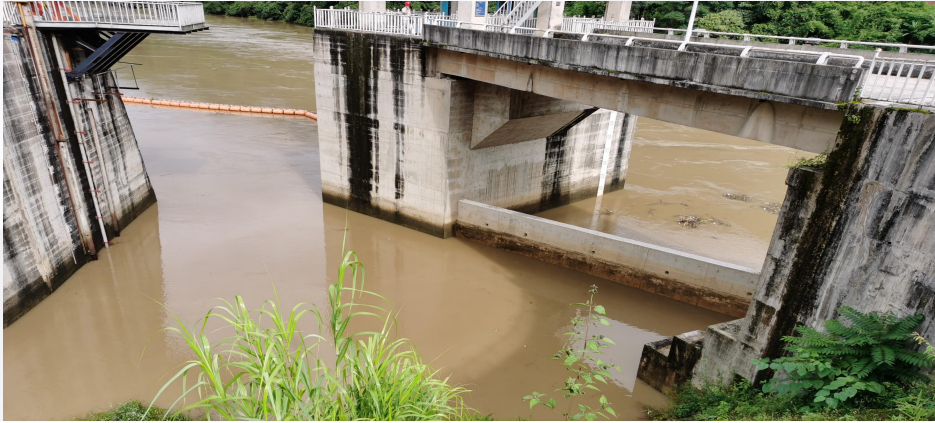
Stable retaining wall during sand flushing

- From rainy season in 2020 up to Year 2021, the power station in succession organized to complete the low water-level operation of the reservoir in rainy season, as well as testing and verification work for normalized sand flushing without shutdown.

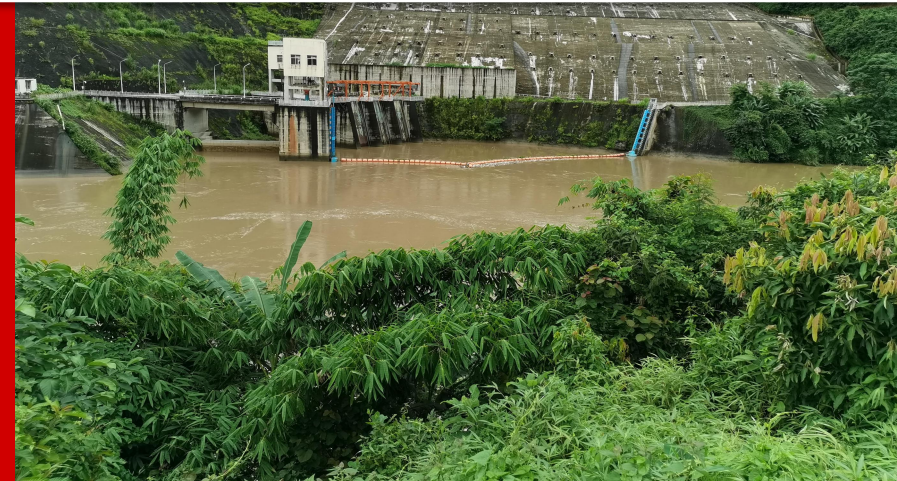
Gentle water flow during sand flushing

At Shweli(1) Hdyropower Station, practice shows that normalized sand flushing can efficiently solve the problem of mud sedimentation, which develops a new thought for high-mud run-off-river station.

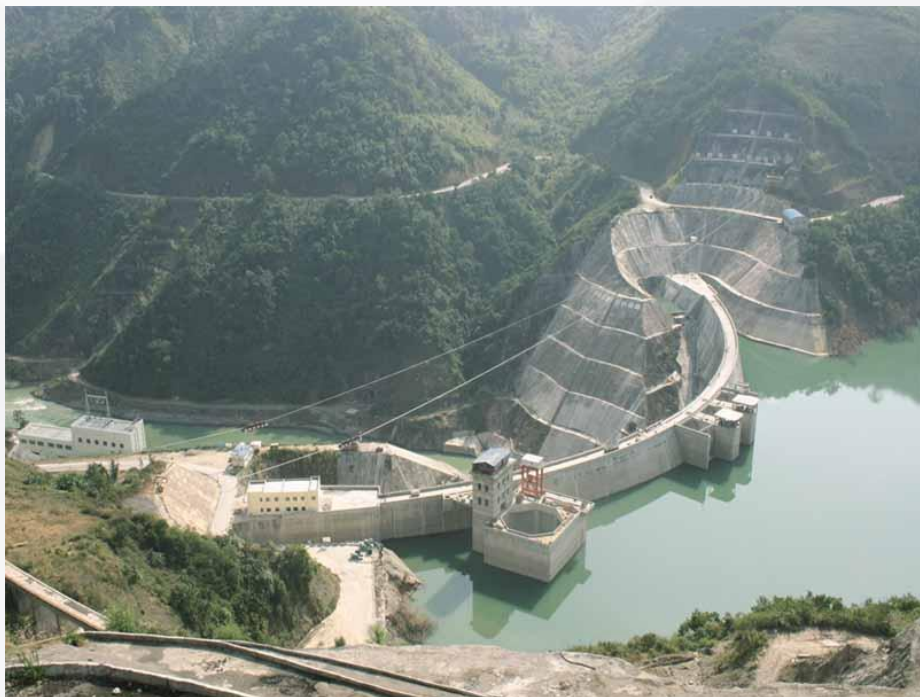
The upstream and downstream reservoir data in contrast

Upstream (Longjiang HPP)	Downstream (Shweli(1) HPP)
Normal water level	872.00m	725.00m
Dead water level	845.00m	717.00m
Capacity below the normal water level	$11.31 \times 10^8 \text{m}^3$	$1144 \times 10^4 \text{m}^3$
Regulated capacity of reservoir	$6.79 \times 10^8 \text{m}^3$	$446 \times 10^4 \text{m}^3$
Regulating capacity	Incomplete annual regulating	Incomplete daily regulating

(◁ Left Picture: Top View of Upstream Longjiang Dam)

To fully use the inflow water, Shweli(1) Hydropower Station invited the Design Institute to study the joint dispatching of reservoir water, and actively built a shared information mechanism. Through multi-year practice, a new pattern of joint reservoir water dispatching was formed in 2019, with obvious benefit achieved. In 2020, Shweli(1) Hydropower Station achieved its record maximal economic benefit, and the total volume of power generation reaches 3814GWh.

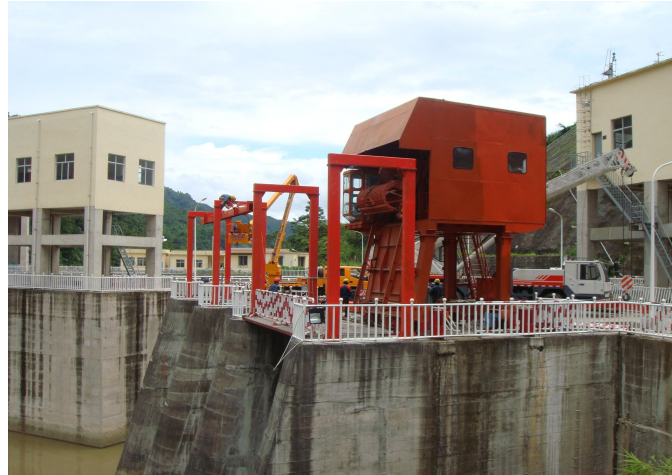
Old trash cleaning machine

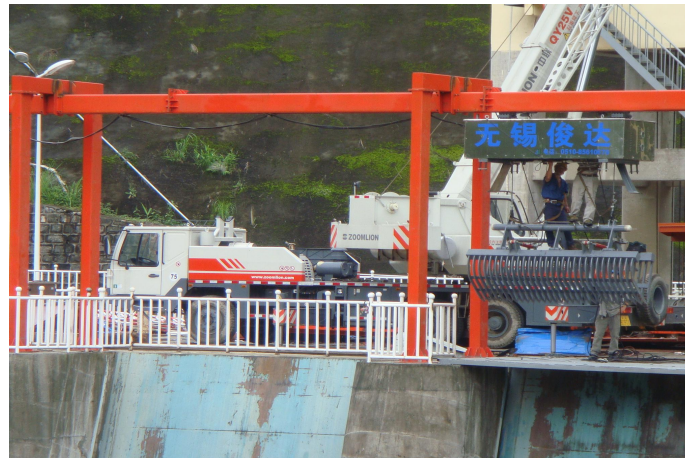
New trash cleaning machine

Make definite the specification of the new-type trash remover, visit quite a few manufacturers domestically, and finally determine the automatic movable grating trash remover. This trash remover owns such characteristics as follows:

- 1) Unique design of travelling guide rails, which can meet the requirements at different positions;
- 2) The guide rails are installed with a limit sensor, which can control the travelling cart to stop at each grabbing place;
- 3) When grabbing, the grabbing teeth are closely engaged with the bars. Through this function, hair-like sewage and entangled objects can be removed;
- 4) The rails crosses the water intake place, and the control cable are also arranged along the rails.

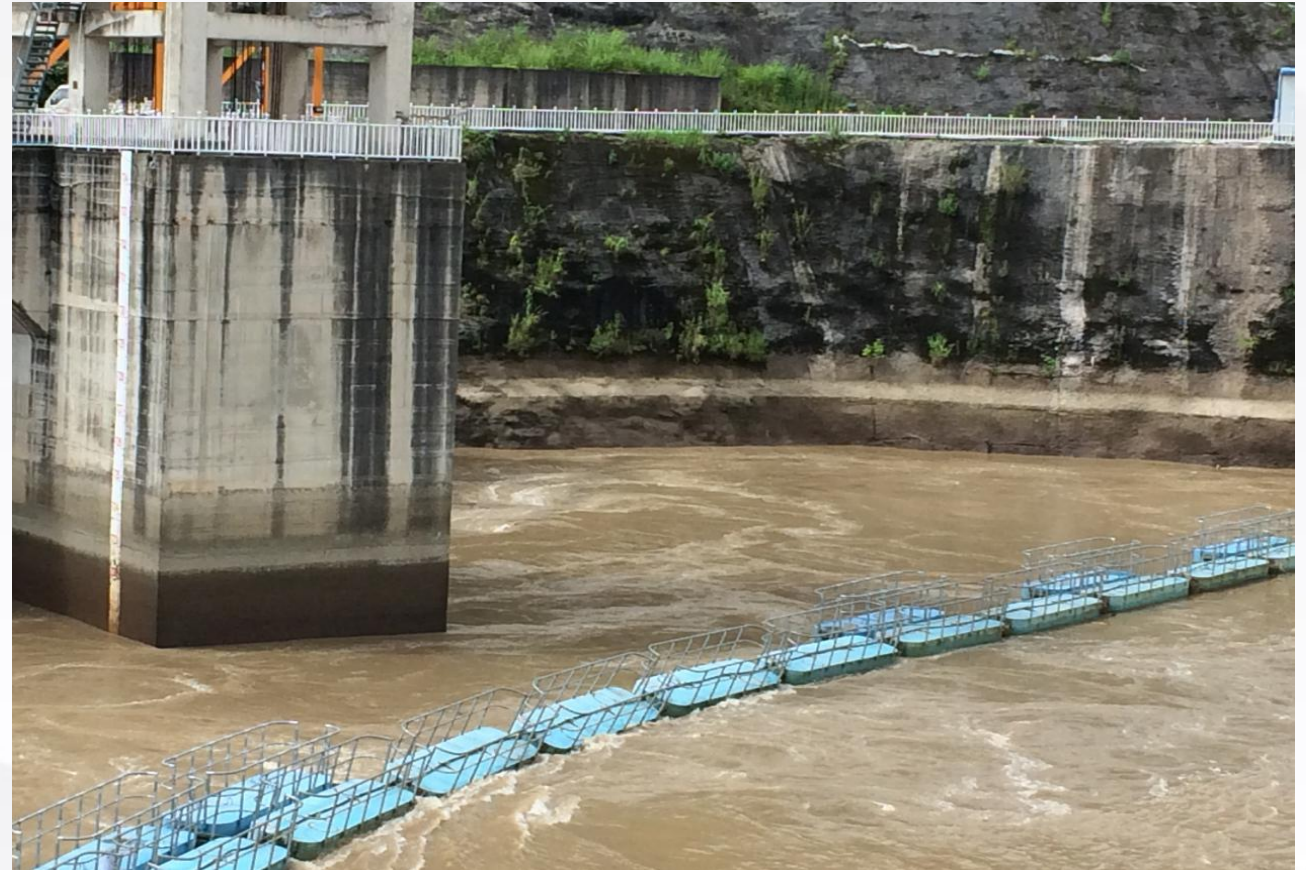
- Turbulent water current in front of the water intake during sourcing sand flushing;
- Floating-tank debris barrier is easy to become tilted influenced by water current;
- Operators are required to hang or untie the floater body on the floating tanks. It is a waste of labor force, difficult to operate, and with high risks.

Floating-tank debris barrier tilted in operation

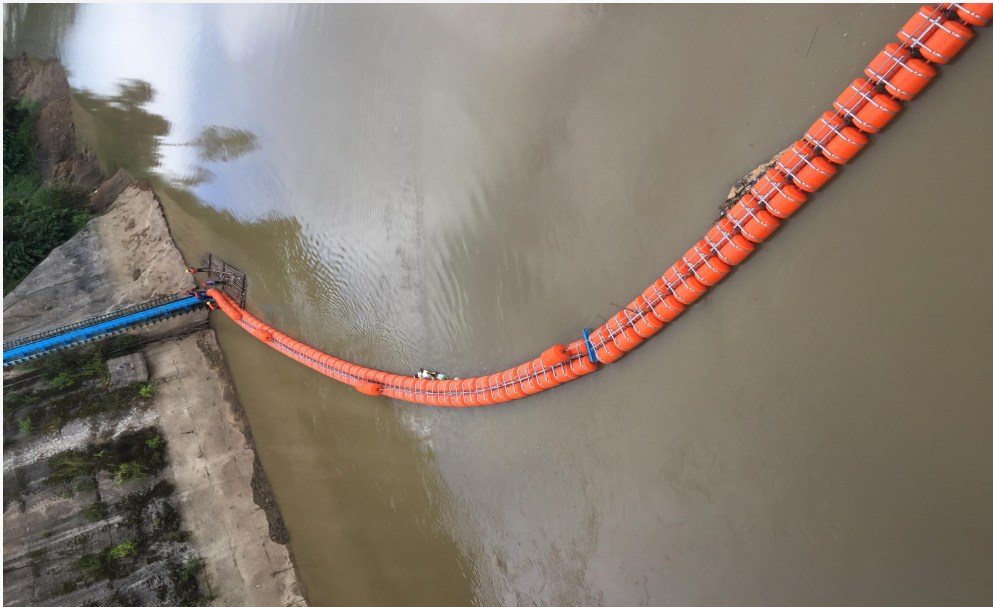
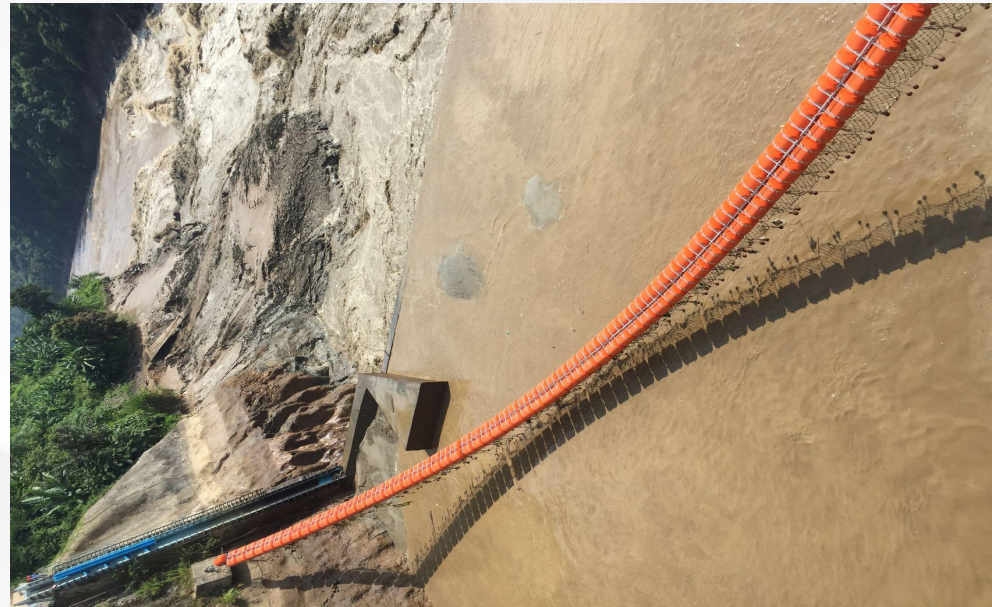
1) Investigation and study commences from Year 2017. Modification of light-weight debris barrier was completed in 2019 in terms of self-buoyance, free maintenance, and low water-level suspended function.

2) By taking the chance of sourcing sand flushing in 2019, build a new reinforced concrete retaining wall under the hoist working bridge of the service access door of flood discharge and sand flushing tunnel, which cuts off the water adding channel from under such bridge to the water intake, and improves the water flow state at water intake.

Modified as light-weight debris barrier

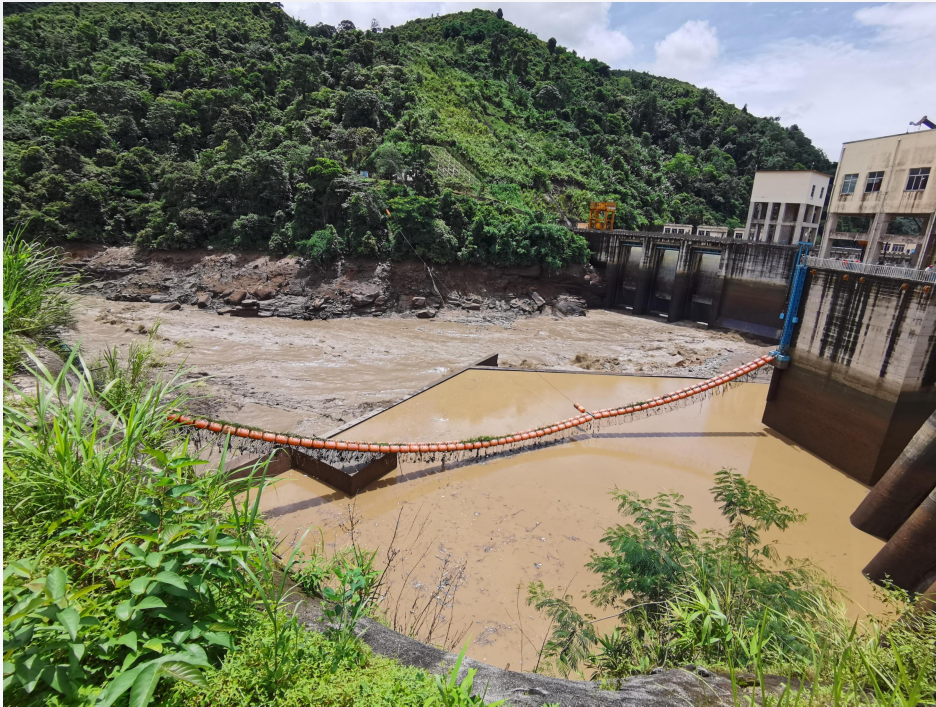
Independent hanging of the light-weight debris barrier

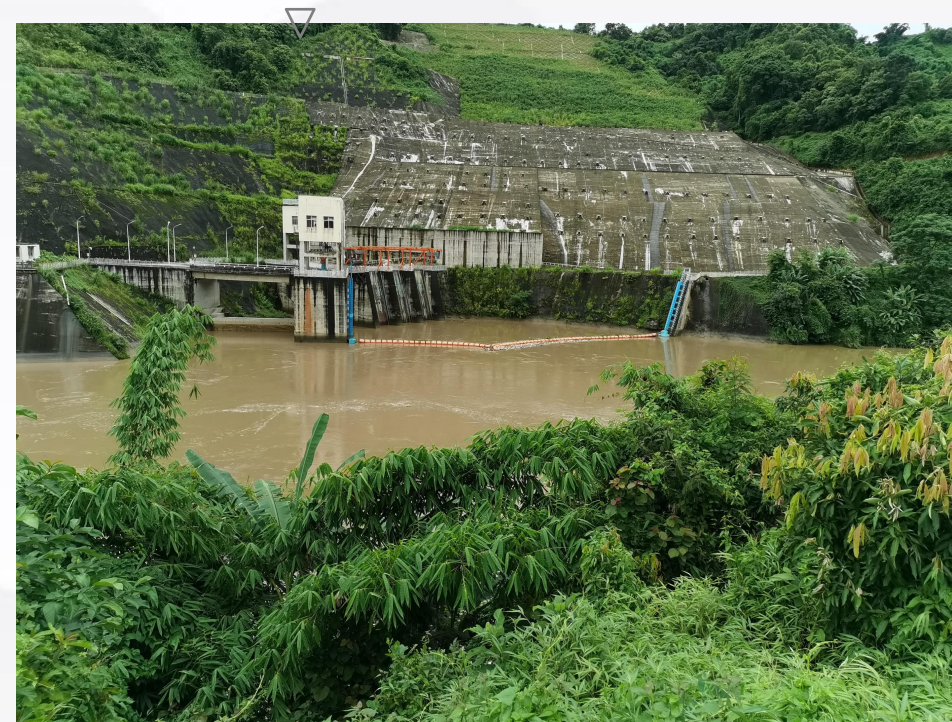
Stable water flow at water intake
